BUILDING SYSTEMS/CONTROLS

HIGHLAND BAPTIST CHURCH
 1101 CHEROKEE ROAD
 LOUISVILLE KY 40204

■ SUMMARY OF FINDINGS:

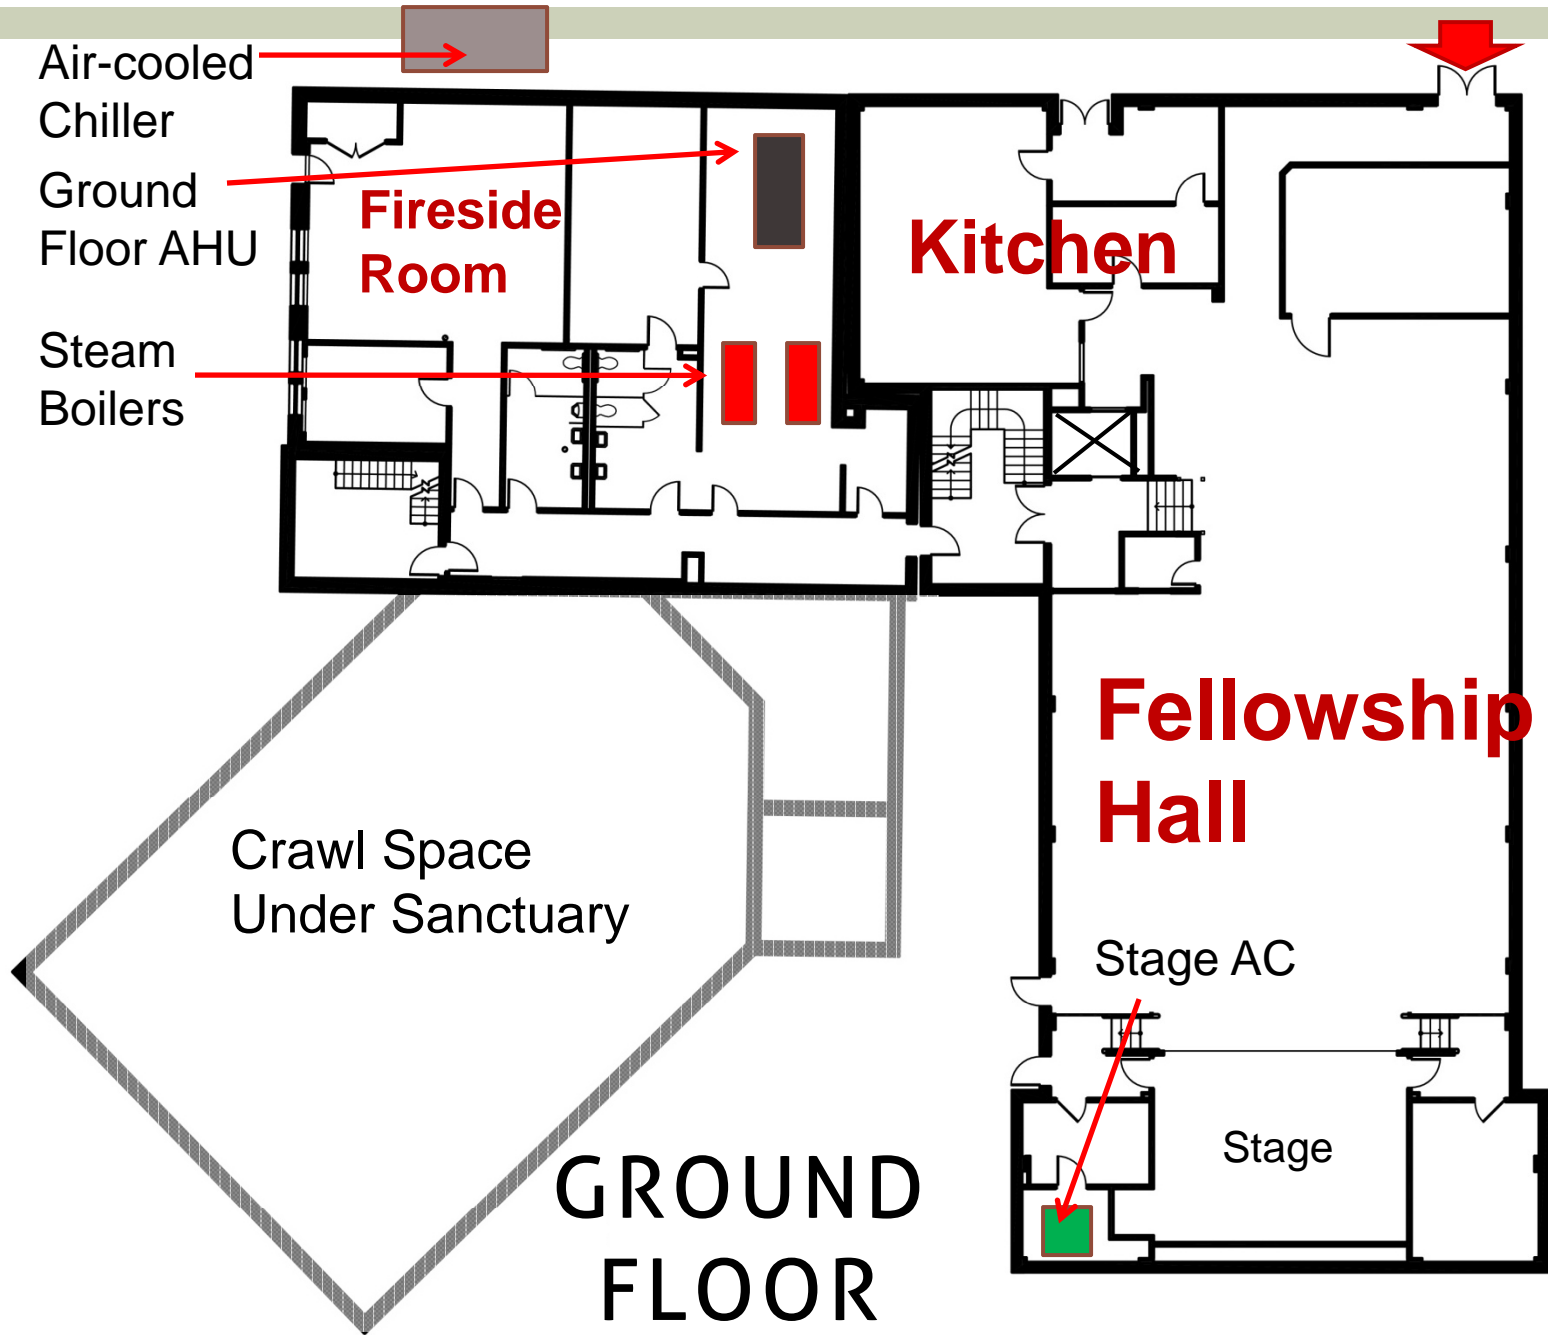
**GROUND
FLOOR**

Air-cooled
Chiller

Ground
Floor AHU

Steam
Boilers

Crawl Space
Under Sanctuary

Stage AC
